GENx-2B SERVICE BULLETIN - 73-0089 R01Revised:
01/11/2021SB 73-0089 R01 ENGINE FUEL AND CONTROL - FUEL NOZZLE MANIFOLDS (73-11-40) -
TOP MAIN FUEL MANIFOLD AND LOWER FUEL MANIFOLD INSPECTION - POST-GENX-2B S/B
73-0038Issued:
05/08/2020

TRANSMITTAL INFORMATIONREVISION 1 TO SERVICE BULLETIN 73-0089

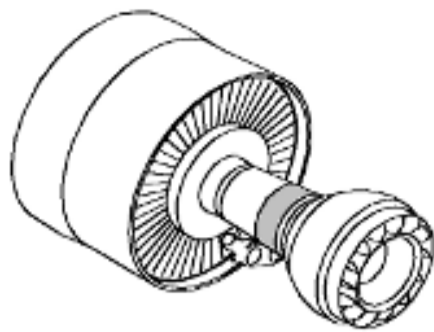
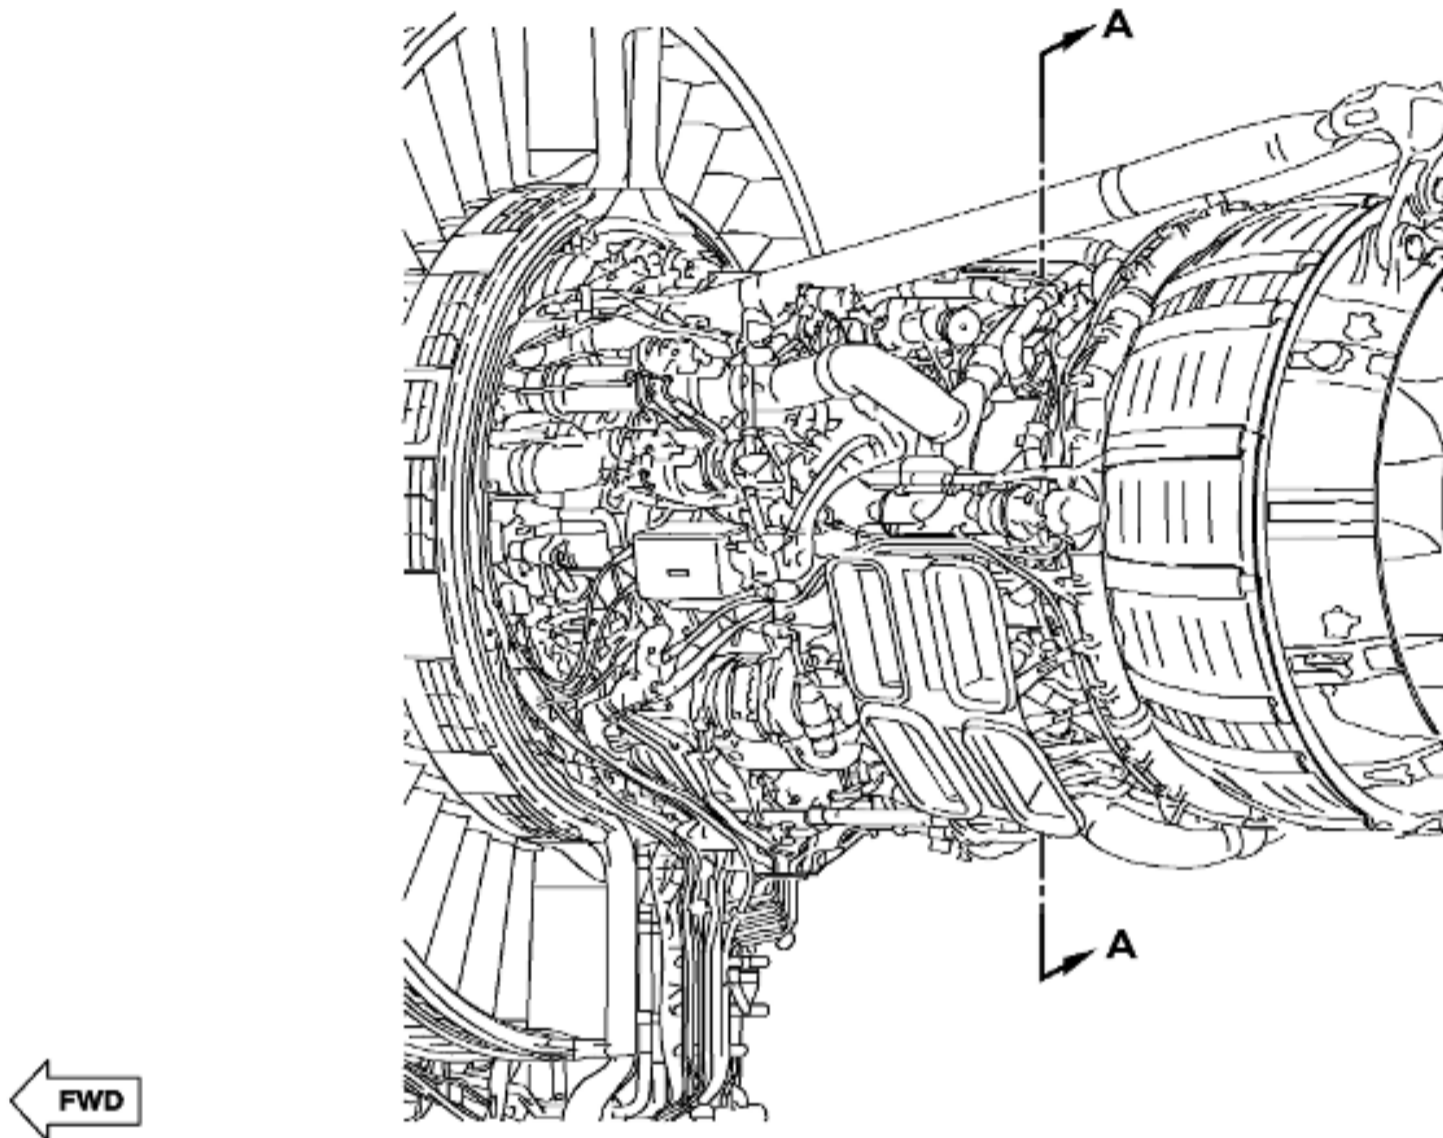
Top Main Fuel Manifold and Lower Fuel Manifold Location
Figure 1

- (4) Do a Class A FPI of the ten brazed block joints on the top main fuel manifold (1, [Figure 1](#)) and lower fuel manifold (2). Refer to the SPM, 70-32-02, SPOT-FLUORESCENT-PENETRANT INSPECTION and do as follows:
 - (a) Indications of 0.03 inch (0.8 mm) or less are permitted.
- (5) Deleted.
- (6) If you find cracks or indications on the top main fuel manifold (1, [Figure 1](#)) or lower fuel manifold (2), replace the affected top main fuel manifold (1) and lower fuel manifold (2) and do as follows:
 - (a) Send the unserviceable top main fuel manifold (1) and/or lower fuel manifold (2) back to GE Aviation. Refer to paragraph 2.D., [Parts Disposition](#).
- (7) Install the top main fuel manifold (1, [Figure 1](#)). Refer to the GENx-2B EM, 72-40-00, ASSEMBLY 001, CONFIG 01, Subtask 72-40-00-440-023 or CONFIG 02, Subtask 72-40-00-440-052.

NOTE: GENx-2B S/B 73-0038 can be used as reference to help with the installation of the lower fuel manifold (2, [Figure 1](#)).
- (9) Do an engine test in a test cell as follows:
 - (a) Do a dry motoring check, an idle leak check, and a high power leak check. Refer to the GENx-2B EM, 72-00-00, TESTING 001 and TESTING 002.

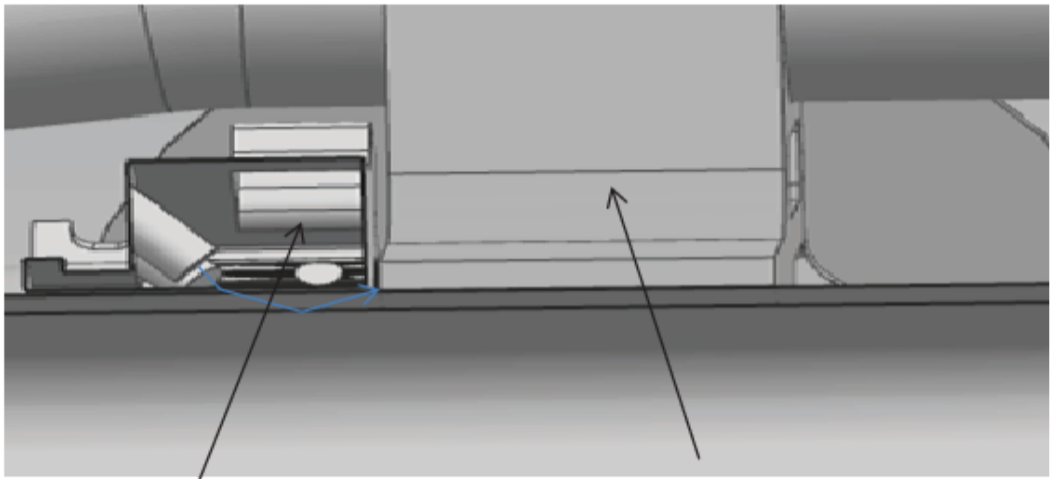
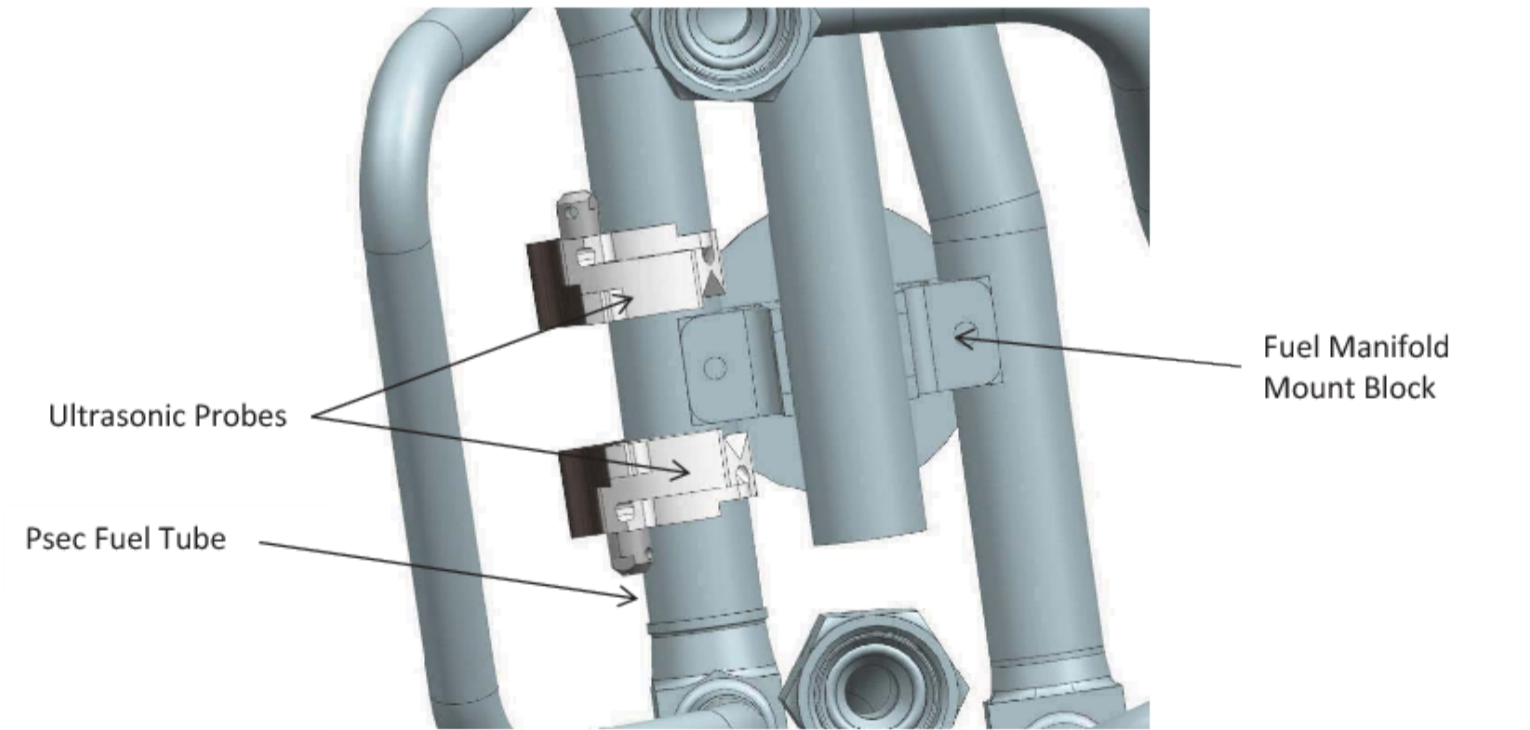
FIGURE 2 - INSPECTION METHOD

Each element switched in turn, generates 70° shear wave in tube, and reflects off tube ID to target cracks originating from OD.

Probe P/N 389-085-151 positioned on Psec CW side and Probe P/N 389-085-161 positioned on the Psec CCW side.

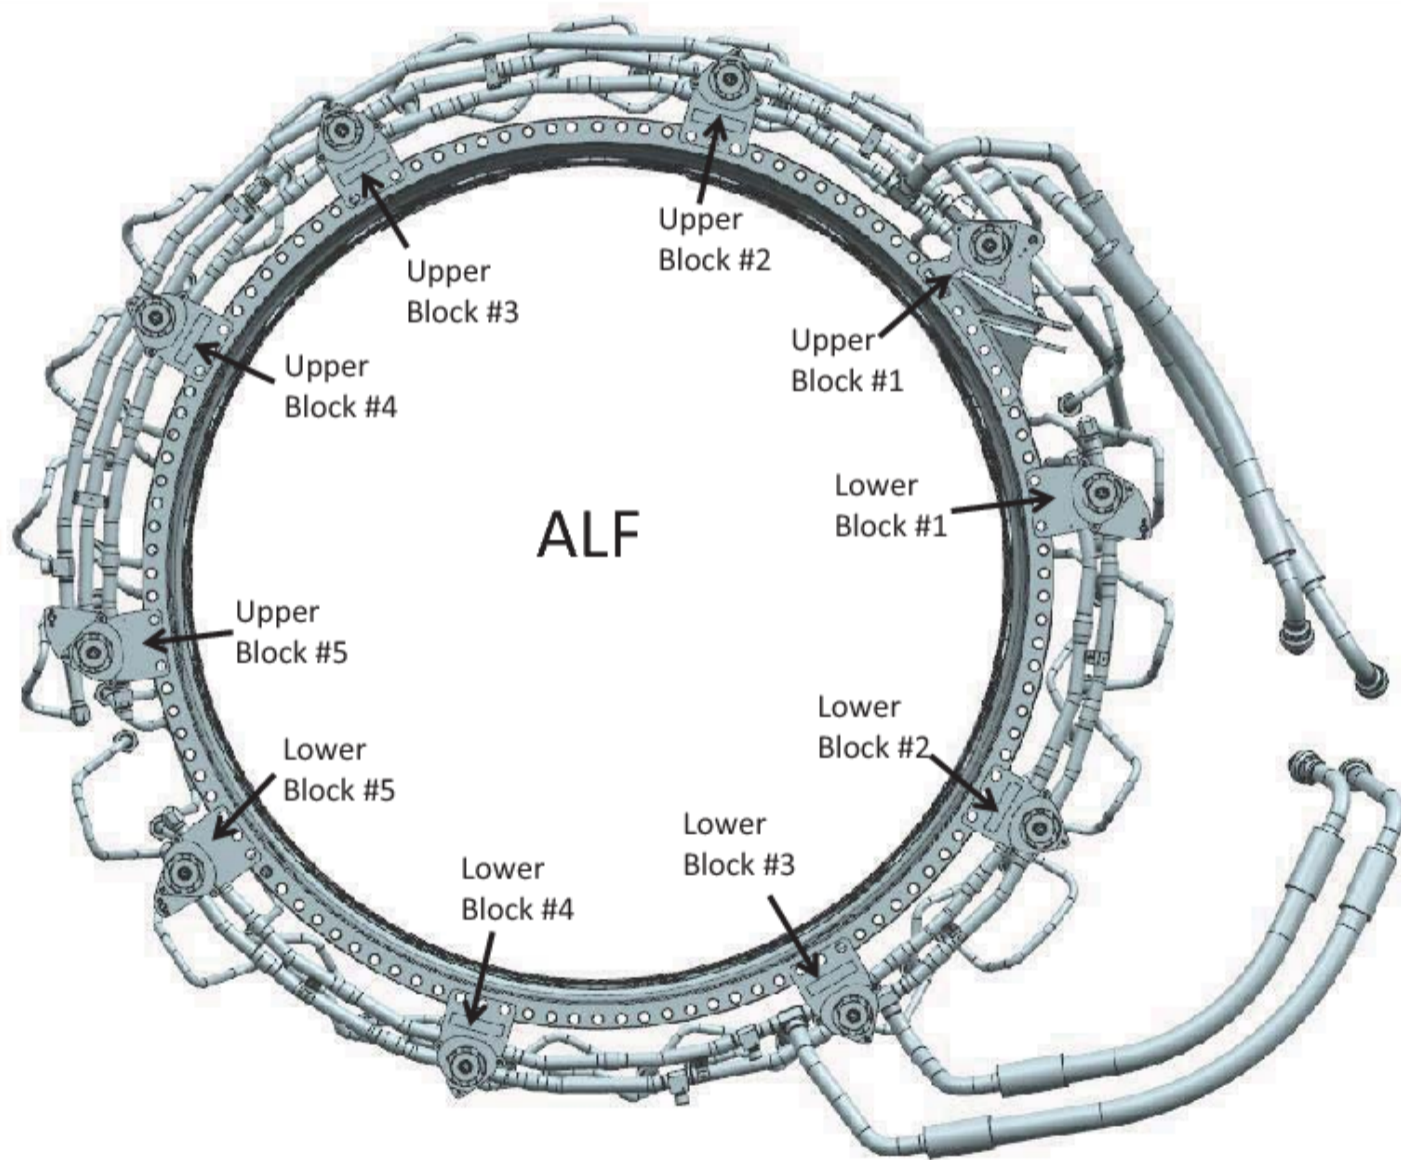
FIGURE 3 - MANIFOLD MOUNT BLOCK LOCATIONS

Note: Only the Psec fuel tube inspection is required adjacent to the mount block locations.

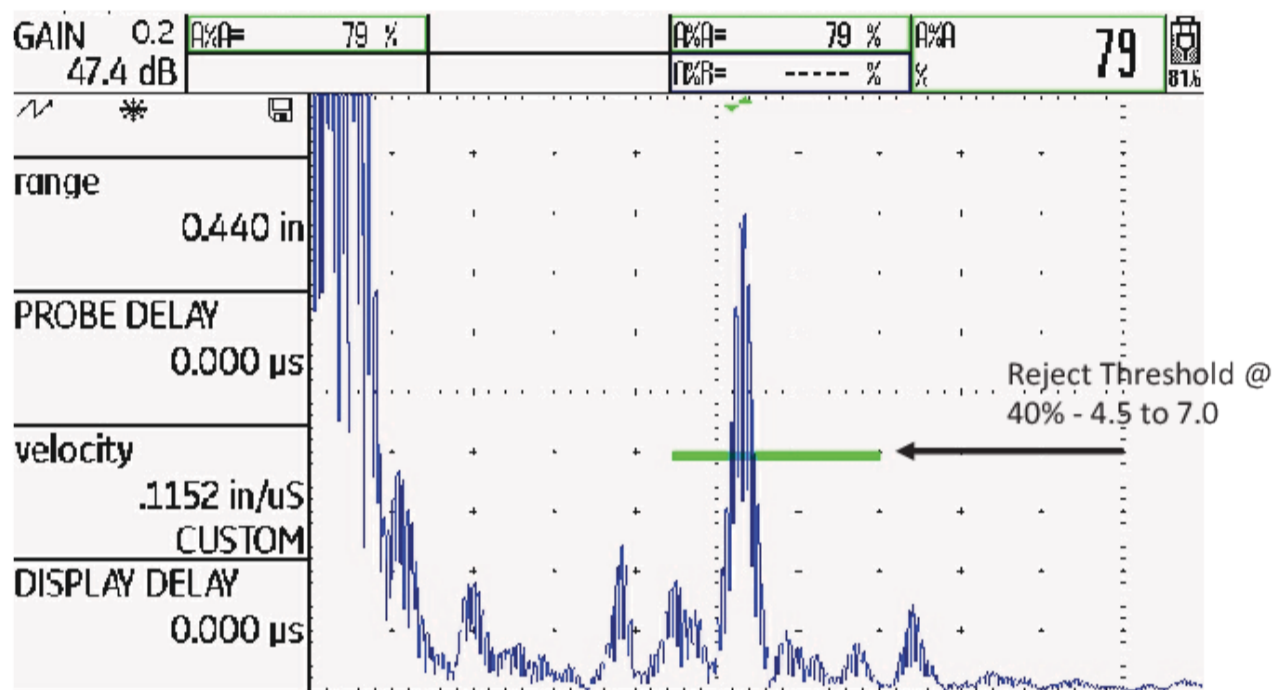
FIGURE 6 - SCREEN DISPLAY – CALIBRATION

- 8.3. Select the probe to use for the area to be inspected.
- 8.4. Set the instrument gain for the probe to be used – refer to gains recorded per section 7.
- 8.5. Set a gate from 4.5 major divisions to the 7th major division on the instrument baseline at a level of 40% FSH. Refer to Figure 6.
- 8.6. Set the transducer switchbox to position number 1.

NOTE: Refer to Figure 6 to clearly understand the reject threshold of 40% and the inspection zone from 4.5 to 7.0 on the horizontal baseline.
